# Archaeological sites in Nepal and India: Concerns of lightning risks

**Abstract**— This study investigates the present-day lightning risks of a large number of archaeological sites in Asia, with special attention to religious monuments in South Asia with invaluable historical value. The study reveals that in most cases, no lightning protection measures (LPM) have been adopted and in several structures, LPM have been adopted but without conducting a methodical risk assessment or standard system design under experts' advice. In a majority of archaeological buildings in Nepal, appropriate lightning protection systems have not been installed, though an apparent air termination system could be observed in the form of a metallic spire or a metallic roof component. However, a system of down conductors and earth terminations has not been properly installed or not installed at all. Both the Department of archaeology and the Department of Urban Development and Building Construction (DUDBC) have not taken adequate steps to install LPS in archaeological sites fearing losing the aesthetic appearance and historical values of the structures. Appropriate LPM has not been adopted even on the str

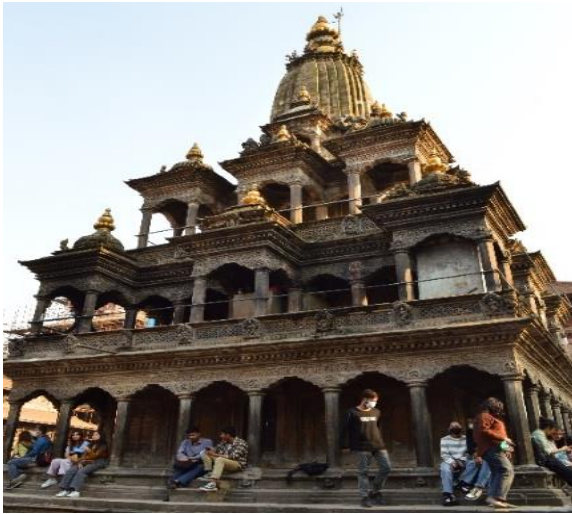
LPS, but some do have down conductor-style metallic strips hanging atop the structure (Figure 1).

Figure 1: Krishna Mandir (Lord Krishna's temple) built on the premise of Patan Durbar square that has an air termination steeple on the top that is not connected to a down conductor system or an earth termination (to be witnessed).

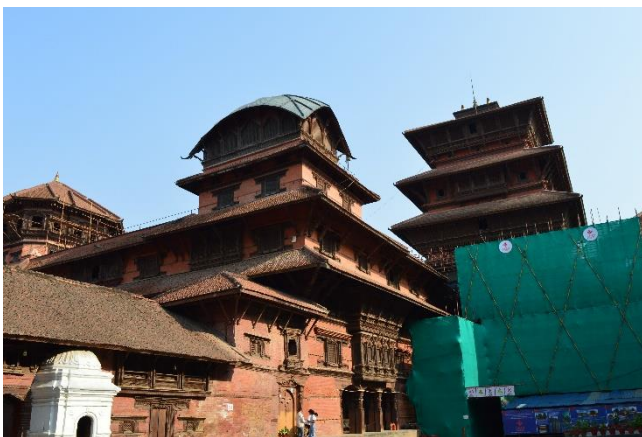
Figure 2: Basantapur tower that is being recently rebuilt after it was demolished by the 2015 massive earthquake. It can be seen on the tower that a single lightning air termination system followed by a single down

conductor is installed on it. We were not allowed to assess the base of the structure citing security reasons.

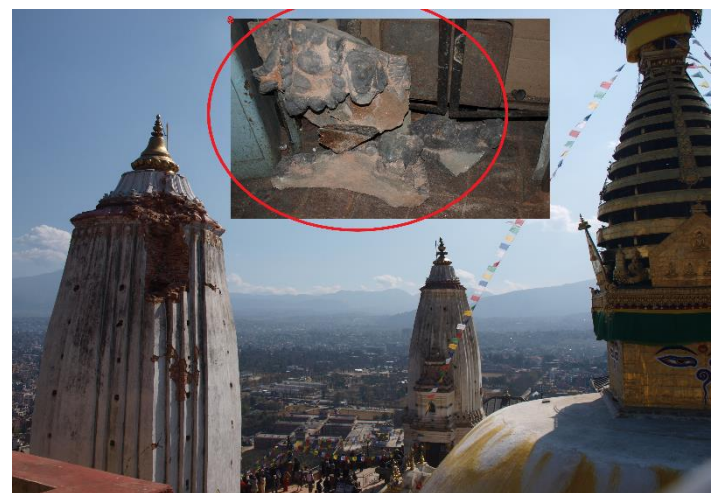
Among them, the Pratappur temple was struck and destroyed by lightning on 13<sup>th</sup> February 2011. Shown in figure 3 is a photograph of a damaged temple taken on the next day it was struck. Pratappur temple was destroyed by lightning sparing the taller structure since it did not have proper lightning protective measures. No appropriate lightning protection measures can be seen on the structure even though it was recently built (Figure 4).

Figure 3: The damaged Pratappur temple at Swyambhunath along with the main stupa and Anantapur temple. Also, shown in the inset is the damaged stone statue that was placed on one side of the main entrance door of the damaged temple.

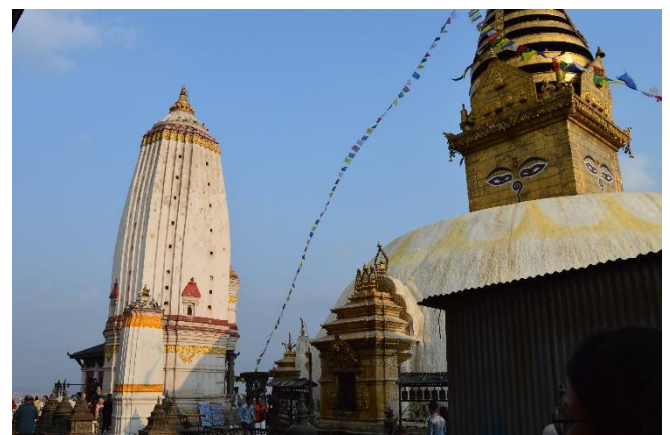
Instead, it is claimed by the local priest that LPM was done within the building after it was erected. Whereas,

- There was no visible air terminal on any of the structures.
- No available down conductors on either of the temple.
- No earth termination system could be observed.

Figure 4: The newly constructed Pratappur temple after it was destroyed by lightning in 2011.

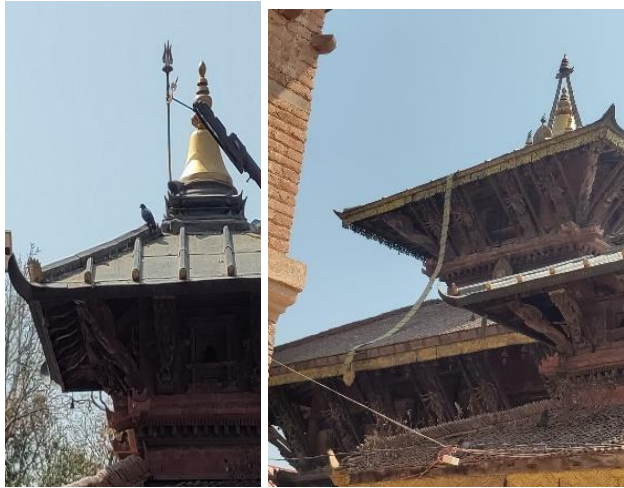
No protective measures against lightning have been taken as it is believed that the gajur (steeple) of the temple itself protects it from lightning. This temple is also a UNESCO world heritage site that is located atop a small hill to the north of Bhaktapur (Figure 5).

Figure 5: Changu Narayan temple located atop a small hill at Bhaktapur. The photograph on the left depicts an air termination system whereas the photograph on the right depicts the down conductor dangling towards the bottom edge of the roof.

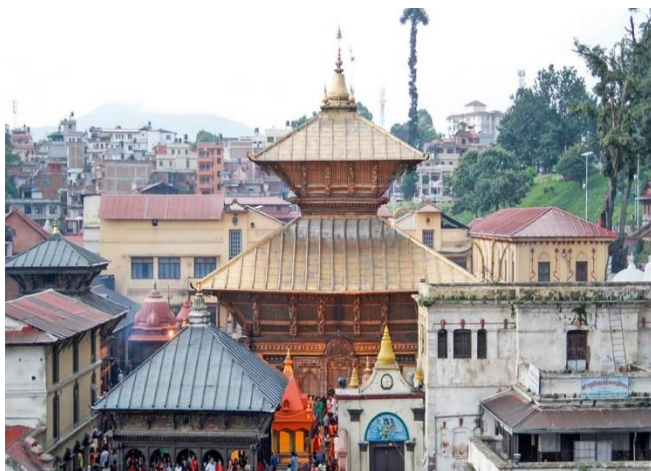
This temple is a sacred Hindu temple classified as a UNESCO world heritage site in 1979 that is believed to have been built in 400 BCE. Despite its historical and religious importance, no appropriate protective measures have been taken. It is believed that the metal steeple and the gold-plated metallic roof protect the temple from lightning (Figure 6). In this temple too, there is a trailing metallic strip that runs from the steeple and dangling below the roof.

Figure 6: Pashupatinath temple located at the bank of Bagmati river in Kathmandu. The steeple and the metallic roof are seen in the photograph.

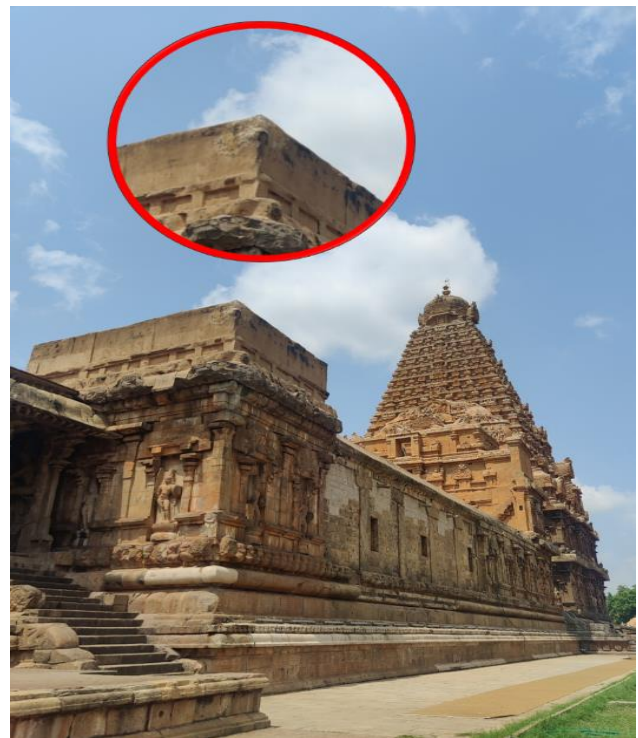
The air termination system is not visible on the main gate although there are down conductors running down both sides to three earth pits. The Down conductors have directly been clamped to the wall and have multiple steep bends. The Earth pit consisted of a GI pipe as an earth electrode.

Whereas, on the main temple building an air Termination System has been installed which is a conventional type that was clamped to the steeple of the temple. There is a lamp on a stand that was placed higher than the tip of the air termination. Two down conductors are taken almost together (at a few centimetre separation). A large number of acute bends on the down conductors can be observed. The copper strip has directly been brought into the ground and no earth pits were observed.

Figure 7: A Photograph of Brihadeeshwara temple located at the bank of the Cauvery river in Tamilnadu India. Shown in the inset is the edge of the temple that was struck by lightning.

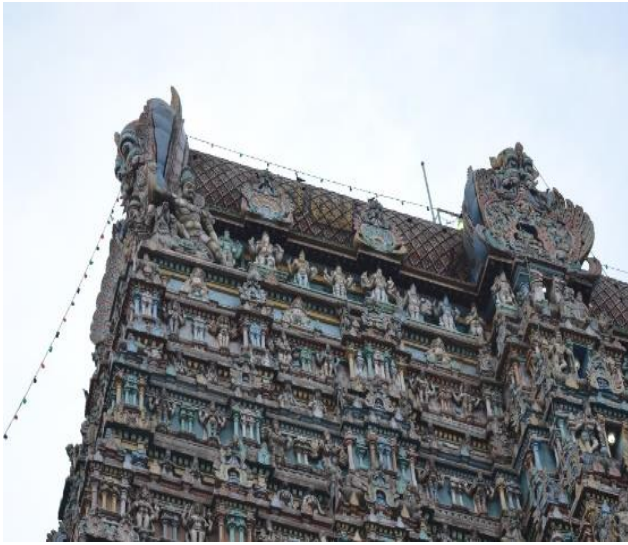
The Meenakshi Amman Temple is located in Madurai Tamilnadu India. It has four large gates in four geographic directions and the main temple building at the middle of the four gates. Each of the 5 structures has an air termination system and all of which are ESE types (Figure 8). However, no down conductor was visibly attached to the ESE air terminals. As these structures are built centuries ago, there is no possibility that they have a steel reinforcement structure to which the air termination could be connected. No earth termination system could also be seen in the vicinity of the structures.

Figure 8: Meenakshi Amman temple located at Madurai Tamilnadu India. An air termination system can be seen on the top of the building.

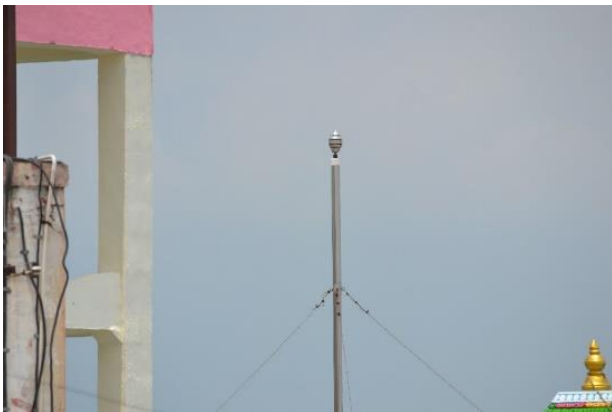
A lightning protection system has been installed on the temple. A single ESE was present on the top of the temple, however, no down conductors were observed (Figure 9). No earth termination system could also be seen around the temple.

An ESE type air terminal was also present close to the entry point of the temple which is at the height of the foot of the temple, with one down conductor touching the ground.

Figure 9: A Photograph of the ESE air termination system installed close to the entrance gate and well below the top of the structures in the close vicinity.

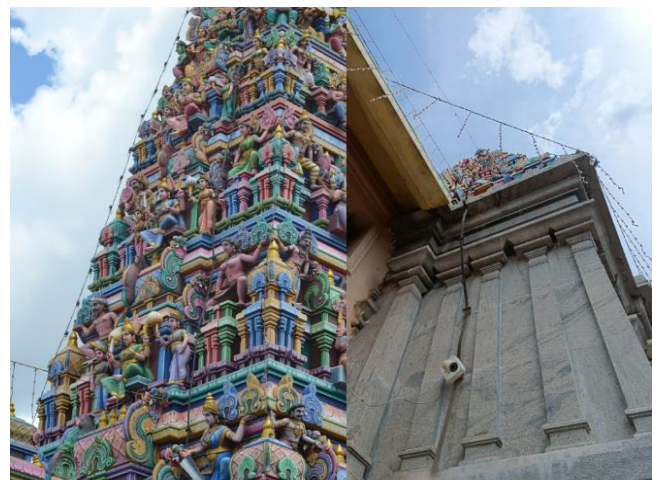
An alternative air termination rod, apparently an ESE device, is installed on the Front gate, whereas the down conductors were not visible nor were the earth termination visible.

Similarly, a conventional type of air termination system is seen to have been installed on the back gate of the temple, whereas, only one down conductor was seen to have been installed. Interestingly, on the down conductor CCTV camera is seen to be fitted (Figure 11).

On the other hand, there was no additional earth termination system instead and the down conductor strip itself has been earthed.

Figure 11: The down conductor system, on which CCTV was installed on the building of Samayapuram temple.

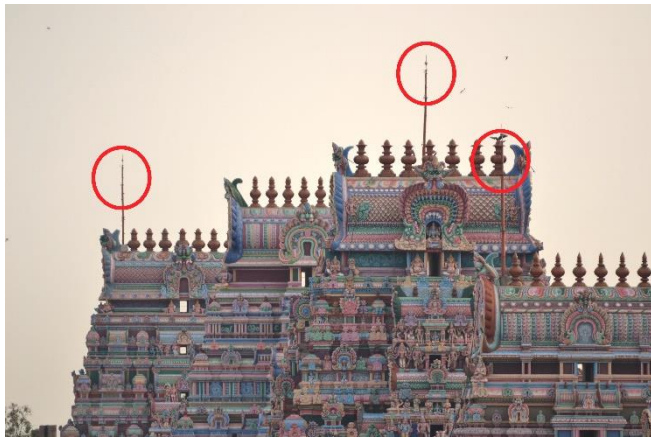
Out of the 21 temples, 12 have been installed with ESE air terminals (Figure 12), whereas, the remaining 9 temples do not have LPM.

Each of the 12 air terminals had a single down conductor each running directly into the earth without proper pits or earth termination system.

Figure 12: Three ESE air termination systems installed on the top of the buildings at Srirangam temple.
