# Clear Evidence of Lightning Strikes to a Building Installed with Multiple ESE Air Terminals

HARTONO Zainal Abidin

*Lightning Research Pte. Ltd.*

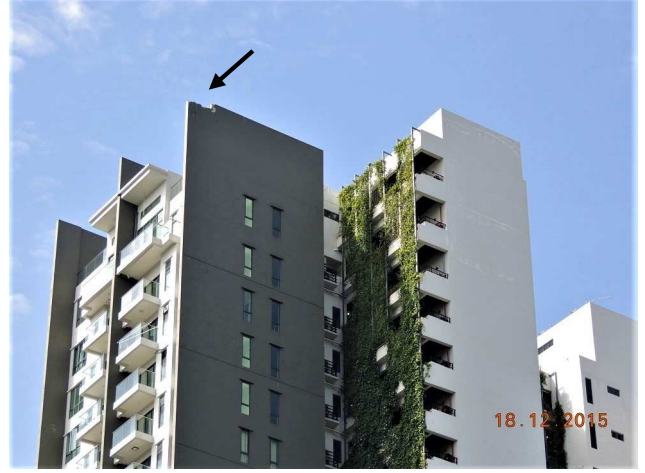
| Photograph date | Item photographed |
|---|---|
| December 2015 | B#2 (Fig. 5) |

Figure 5 Bypass #2

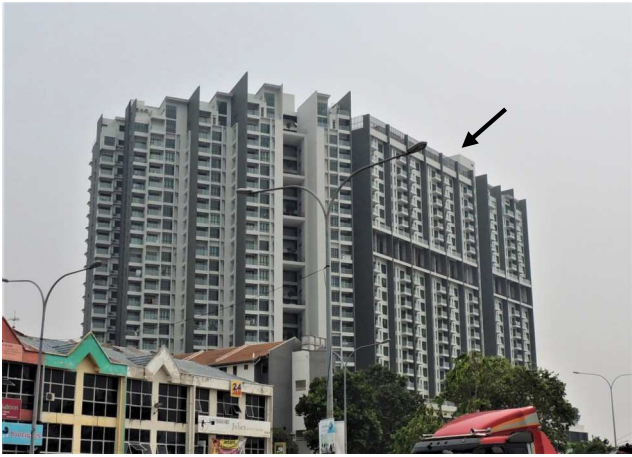
Figure 3 View of UNIV360 Place building from the West showing the location of Bypass #1

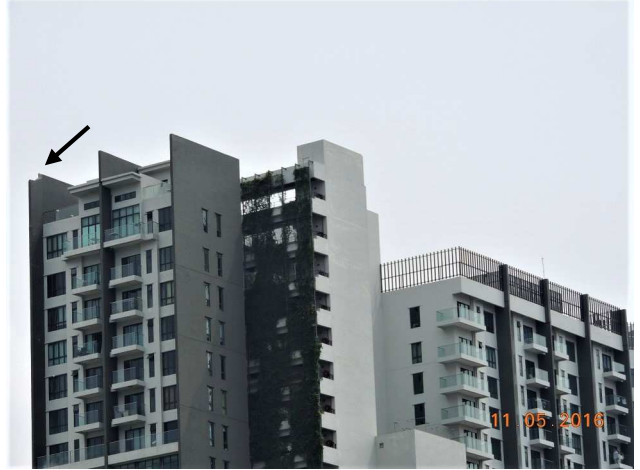
Figure 6 Bypass #3 (Note: Bypass #2 has been repaired)

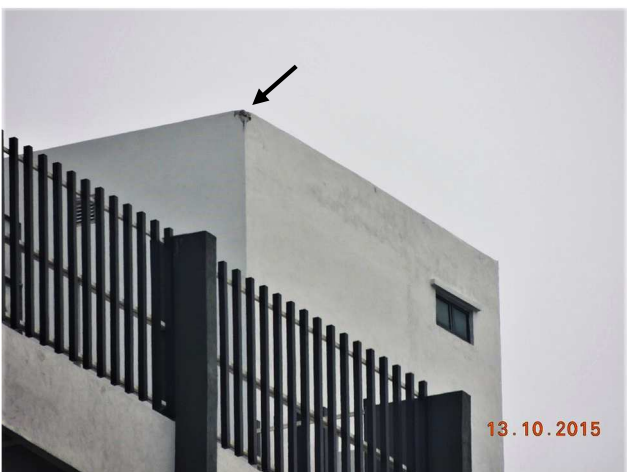
| Photograph date | Item photographed |
|---|---|
| October 2015 | Bypass #1 i.e., B#1 (Fig. 4) |

Figure 4 Close-up view of Bypass #1

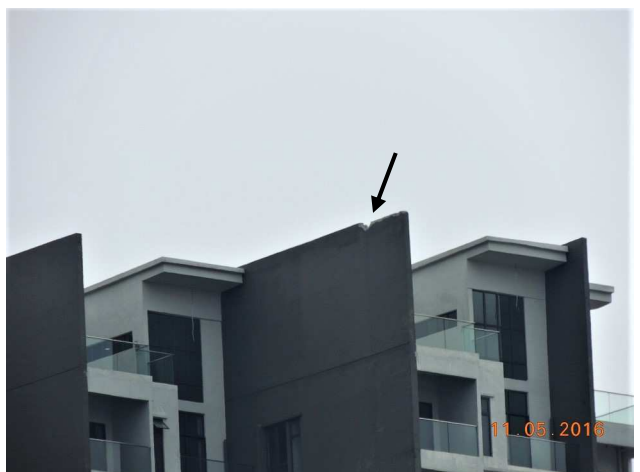
The above AT was installed at the centre of the roof which is approximately 140 m long. The claimed protection radius of the AT must be much bigger than 70 m for it to protect the whole building from lightning strikes. Since the lateral distance between B#4 and ESE#1 is approximately 60 m, this

is clear evidence that the protection radius of ESE#1 is smaller than 60 m. Furthermore, since more bypasses continued to occur after ESE#1 has been remounted on a taller pole, this is clear evidence that this practice is impractical.

Figure 7 Bypass #4

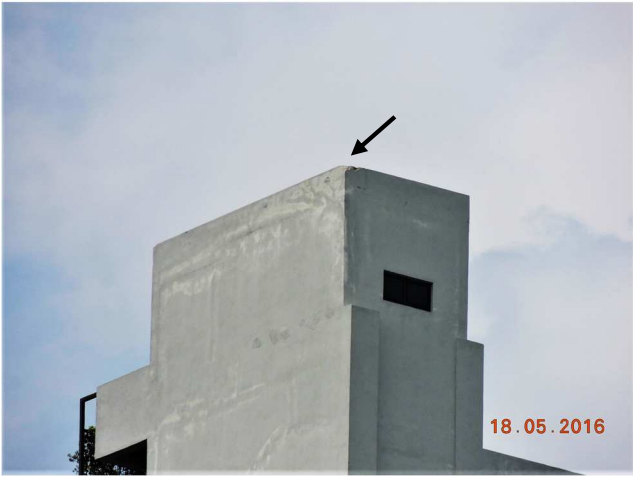
Figure 8 Bypass #5

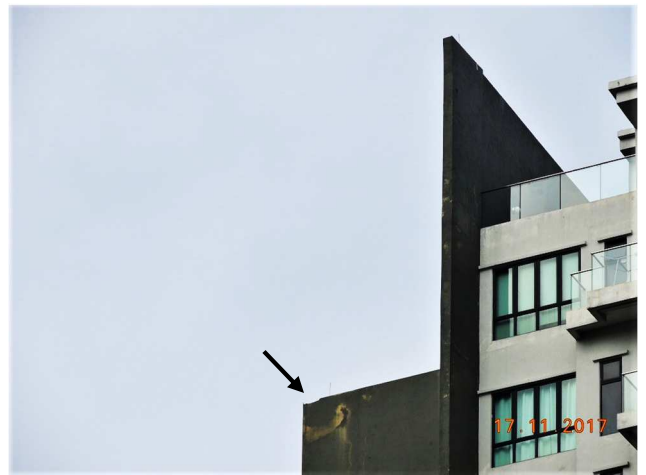
| Photograph date | Item photographed |
|---|---|
| November 2017 | B#6 (Fig. 12) |

Figure 12 Bypass #6 (Note: Bypass #3 has been repaired)

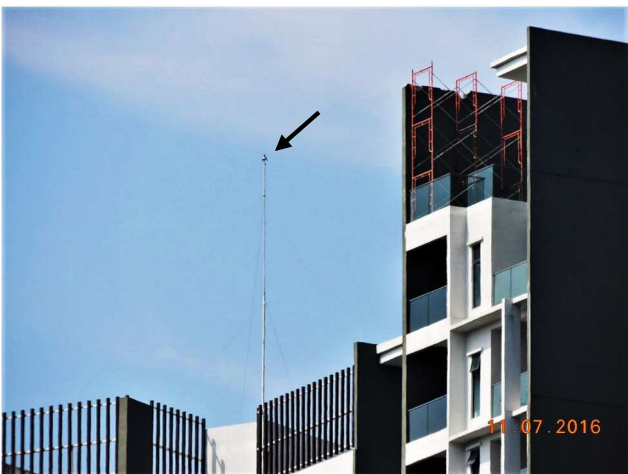
Figure 10 ESE#1 after being remounted on a taller pole (Note: Bypass #4 was under repair)

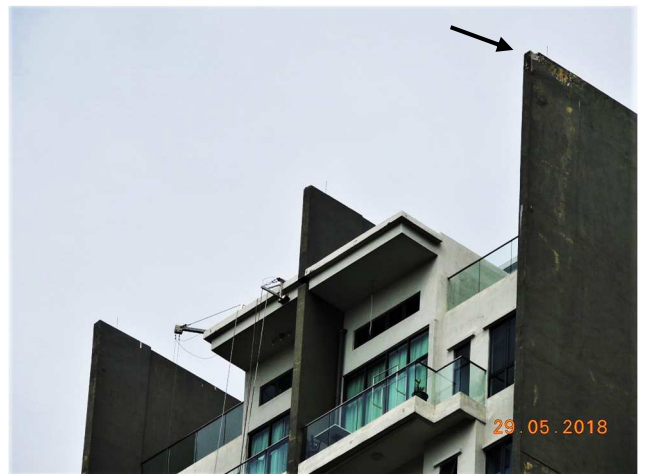
However, the building was still repeatedly struck by lightning after ESE#2 and ESE#3 were installed. The horizontal distance between B#7 and ESE#2 is approximately 45 m while the horizontal distance between B#9 and ESE#3 is approximately 20 m. These bypasses are clear evidence that the protection radius of the two ESE-AT is less than 20 m.

Figure 13 Bypass #7

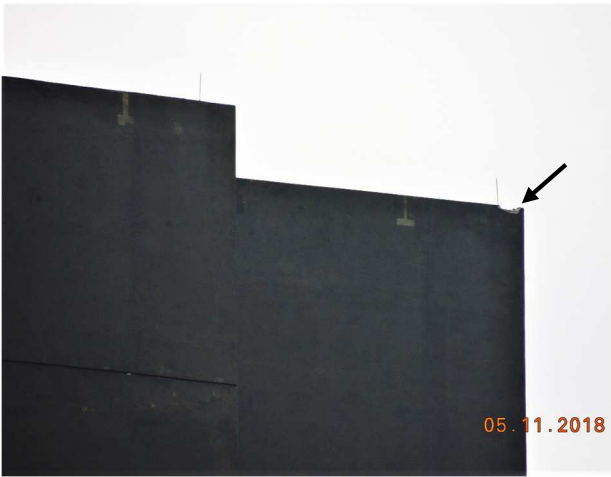
| Photograph date | Item photographed |
|---|---|
| November 2018 | B#8 (Fig. 14) |

Figure 14 Bypass #8

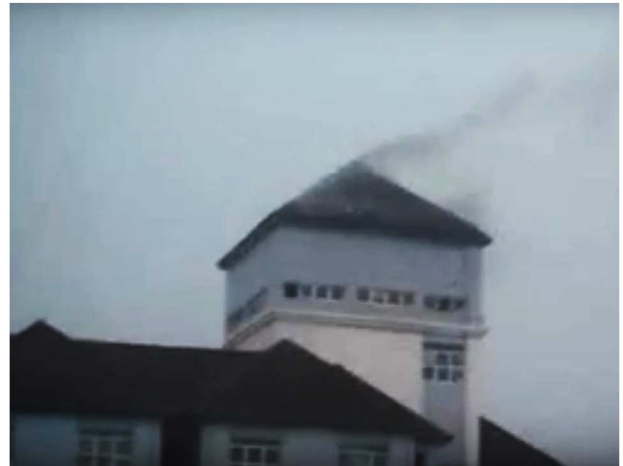
This installation also suggests that the proponent may have followed the actions taken by Universiti Putra Malaysia (UPM) in mitigating the failure of an ESE-AT at one of their residential colleges located about 1.5 km away from the UNIV360 Place. Two additional ESE-AT were installed at the Eleventh College building (*Bangunan Kolej 11*) a year after it was struck by lightning in 2010 (Figs. 16 and 17).

Figure 16 Screen grab of the smoldering roof of one of the building's two water tank towers soon after the lightning strike in April 2010

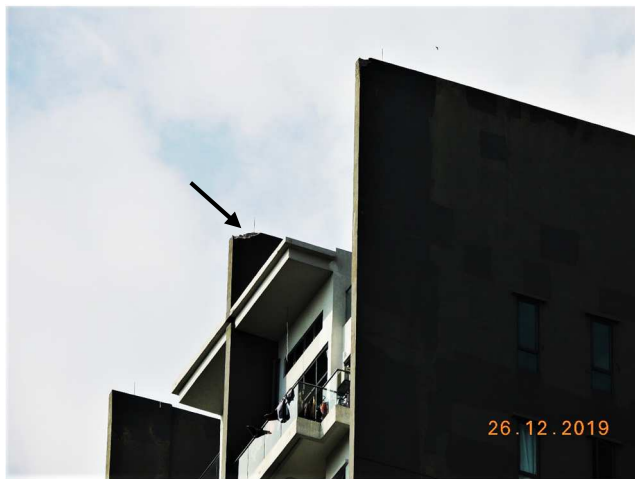
Figure 15 Bypass #9 (Note: Bypass #7 still not repaired)

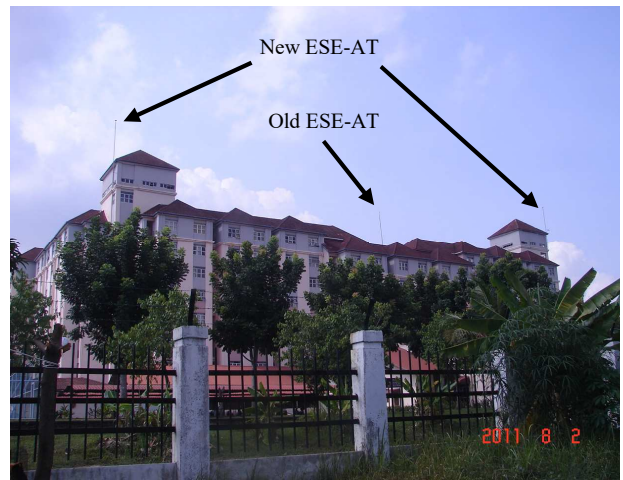
Figure 17 Two new ESE-AT were seen installed at the water tank towers a year later. (<https://goo.gl/maps/kS95jTgfCZs1iLu2A>)

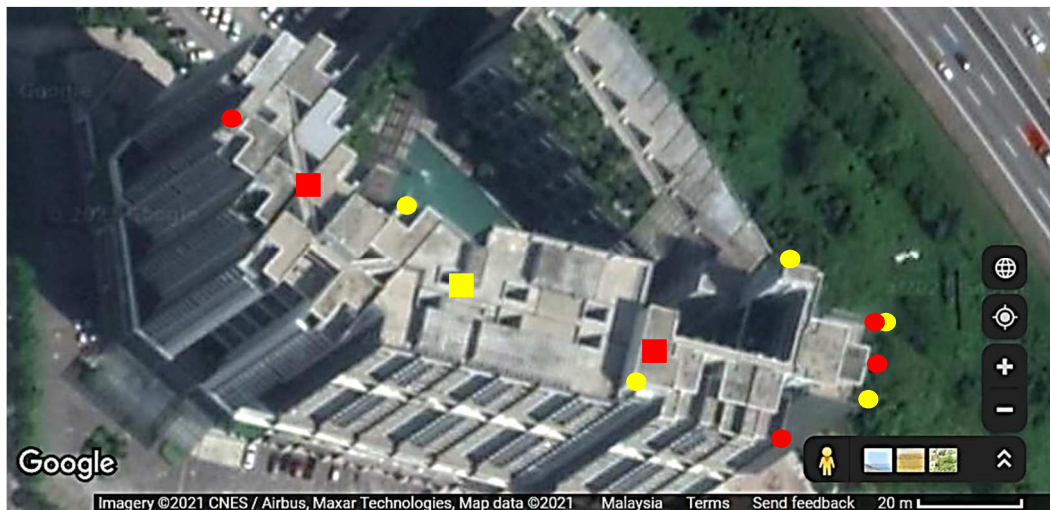
cannot protect the periphery of the building from being struck by lightning repeatedly. Increasing the height of the ESE-AT mounting pole has no effect on the claimed protection radius either. Furthermore, adding more ESE-AT on the building will also not protect it from being struck by lightning repeatedly. (See Fig. 18 for their approximate placements on the roof)

Figure 18 Google satellite view of the UNIV360 Place showing the approximate locations of ESE#1 (yellow square) and ESE#2/#3 (red squares). The locations of the Phase 1 (yellow dots) and Phase 2 (red dots) bypasses are also as shown above.

The installation of Franklin rods near the corners and pointed features of the building seemed to have reduced the frequency and size of the bypasses. This suggests that placing them directly on those places in full compliance with the IEC62305 standard can result with better lightning interception and prevent the occurrence of sizeable bypasses altogether.
