## The ESE and CVM Lightning Air Terminals: A 25 Year Photographic Record of Chronic Failures

Z. A. Hartono and I. Robiah

# APL 2017

The 10<sup>th</sup> Asia Pacific International Conference on Lightning  
May 16 - 19, 2017, Krabi Resort, Krabi, Thailand

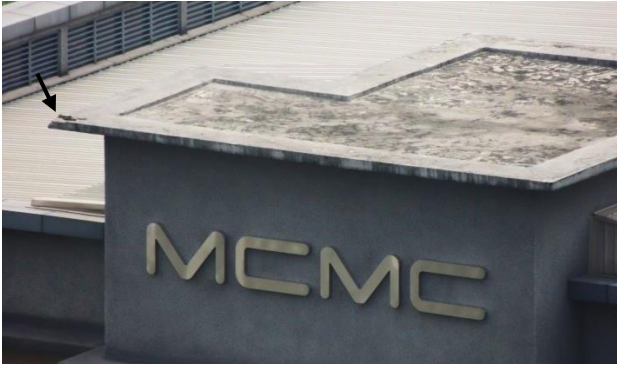
Fig. 2.1. A small bypass located at the corner of the roof of a public building. This is the most common shape of bypasses seen in Malaysia.

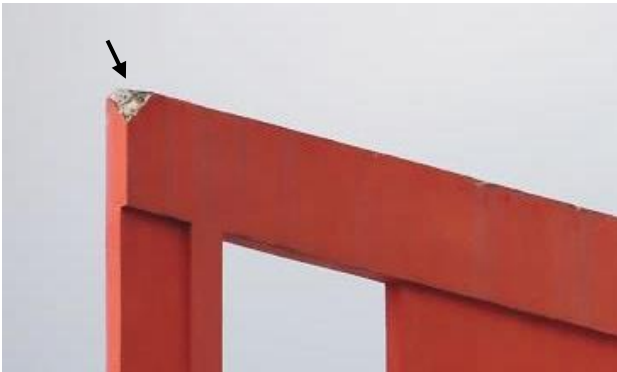
Fig. 2.2. A small bypass on top of a facade with the lightning impact point at the wall end.

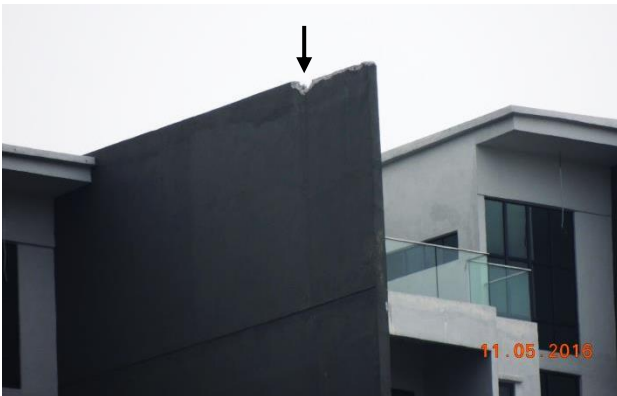
Fig. 2.3. A small bypass on top of a firewall with the lightning impact point located away from the wall end.

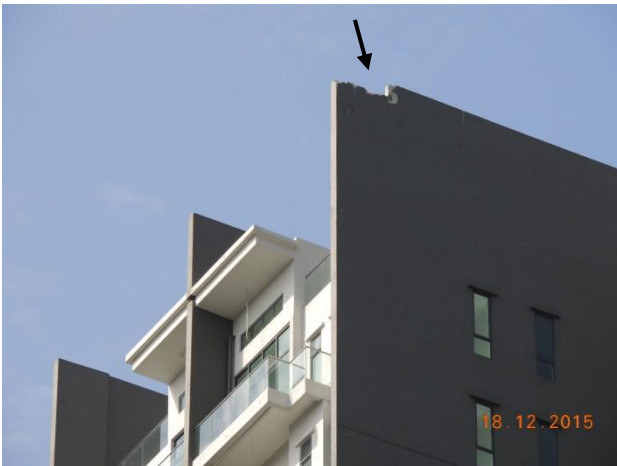
Fig. 2.4. A larger bypass on top of a firewall.

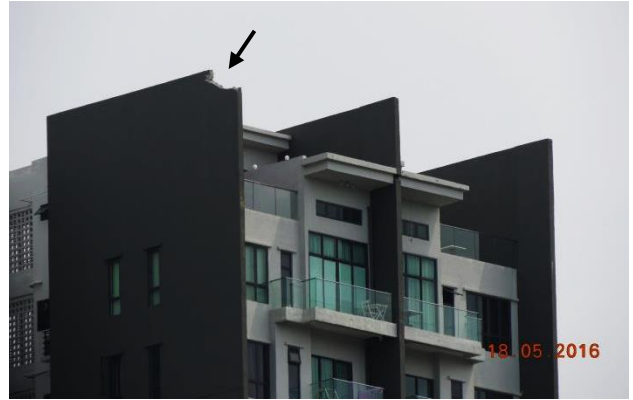
Fig. 2.5. A much larger bypass on top of a firewall. The same bypass shown in fig. 2.4 had been repaired earlier.

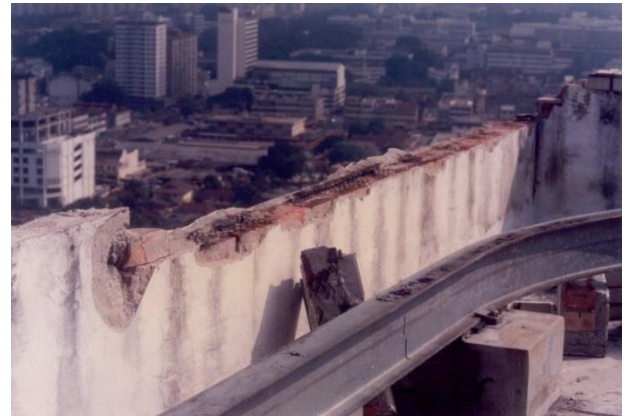
Fig. 2.6. A very large bypass on the parapet wall, photographed in 1991. The building had just been installed with a CVM air terminal.

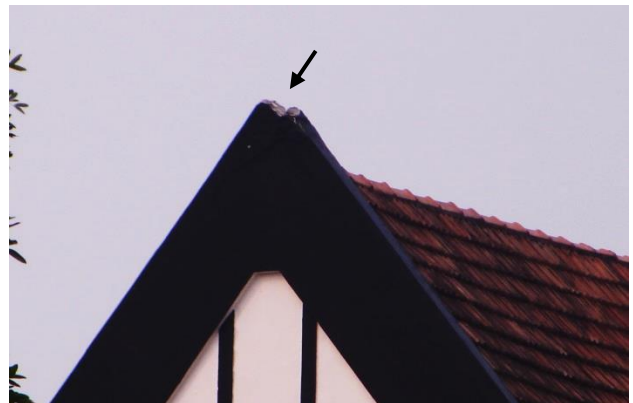
Fig. 2.7. A bypass on top of a pointed facade.

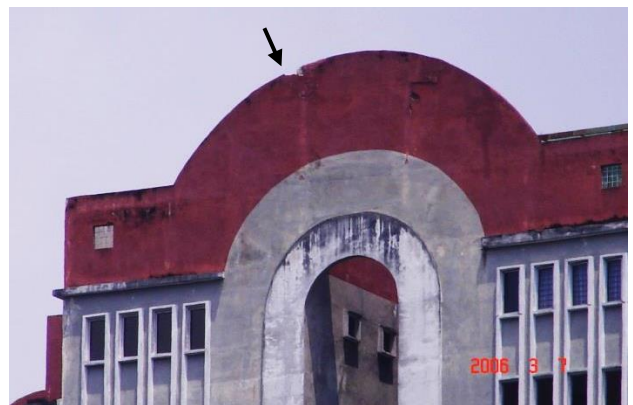
Fig. 2.8. A bypass on top of a curved facade.

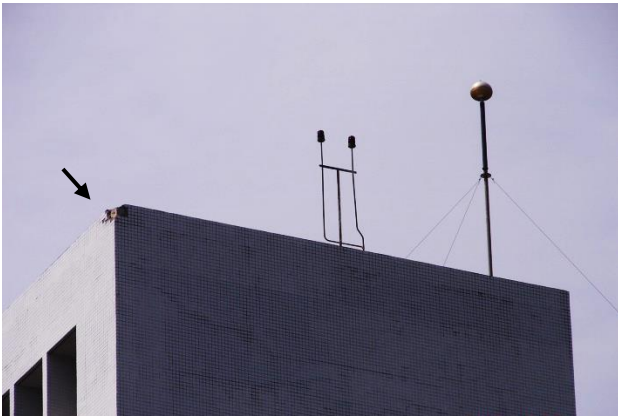
Fig. 3.1. A bypass near a CVM air terminal. The building has been struck about six times before this bypass occurrence.

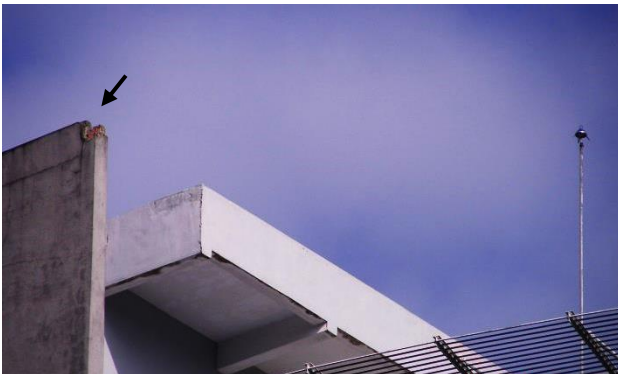
Fig. 3.2. A bypass on one end of a façade near an ESE air terminal. A similar bypass also occurred at the opposite end of the same building.

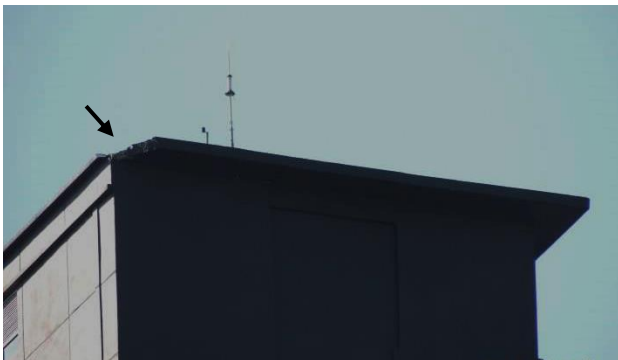
Fig. 3.3. A bypass on one corner of the roof of the elevator motor room near an ESE air terminal. Another bypass had occurred earlier at one of the distant corners of the same building.

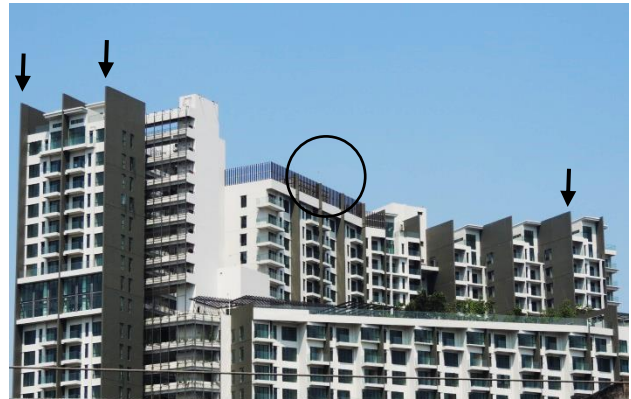
struck more than once per year. For example, the Univ360 apartment in Kuala Lumpur was struck at least six times over a period of two years resulting in three major bypasses.

Fig. 3.4. The Univ360 apartment was struck at least six times within a period of two years. The arrows indicate the locations of the major bypasses. See also figs 2.3, 2.4 and 2.5.

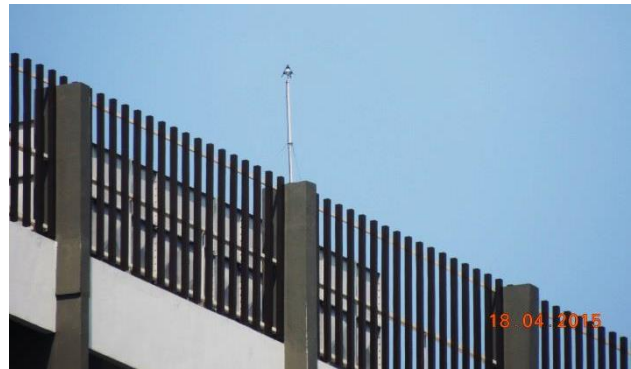
Fig. 3.5. The ESE air terminal installed on the Univ360 apartment and located at the center of the roof (circle in fig. 3.4).

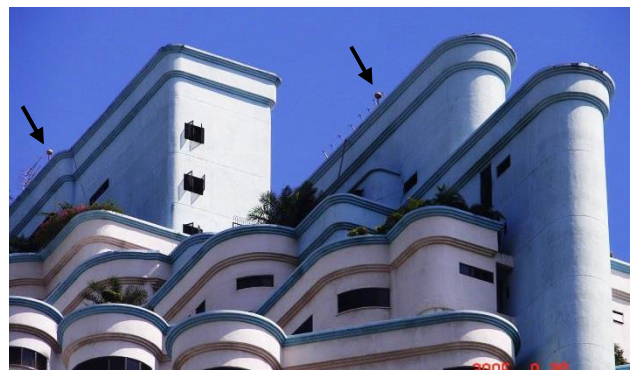
Fig. 4.1. A 100m high apartment building with multi-level roofs installed with two CVM air terminals (arrowed).

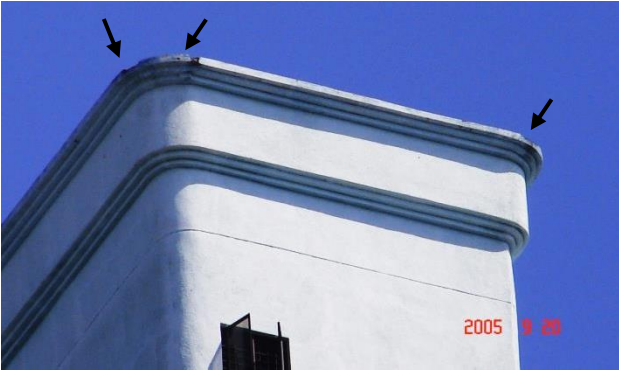
Fig. 4.2. Although located between two CVM air terminals, several bypasses were observed on this section of the upper level roof.

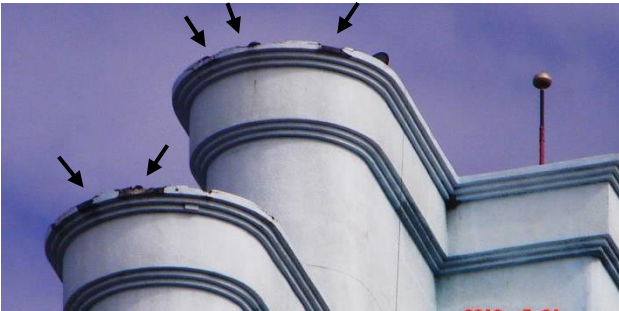
Fig. 4.3. Multiple bypasses were observed on the lower level parapet walls located near the CVM air terminal.

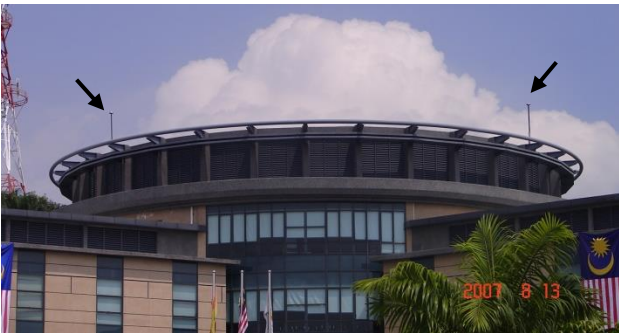
Fig. 4.4. Two second generation CVM air terminals (arrowed) installed on a low-rise public building.

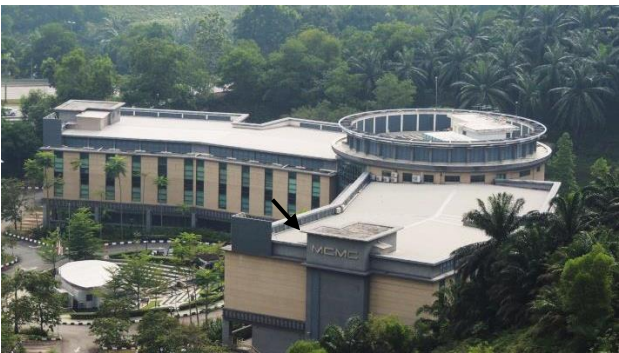
Fig. 4.5. A bypass was observed on the corner of the roof (arrowed). See fig. 2.1 for a close-up picture of the bypass.

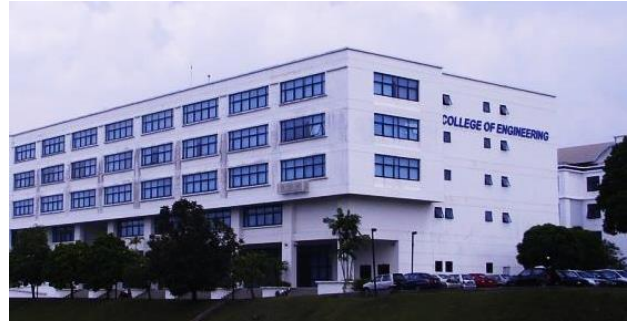
Fig. 4.6. A low-rise college building installed with one ESE and one CVM air terminals.

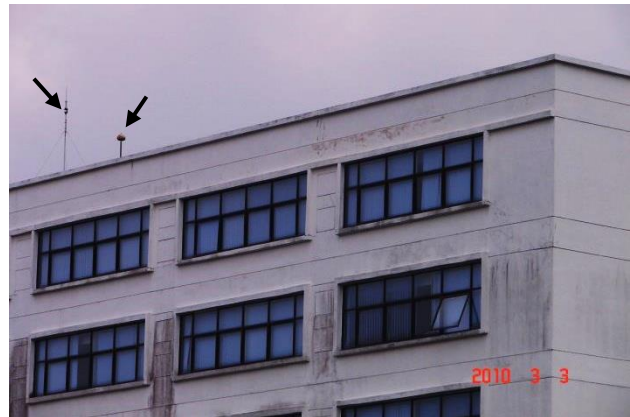
Fig. 4.7. The same building installed with two ESE/CVM air terminals (arrowed) and photographed without a bypass in 2010.

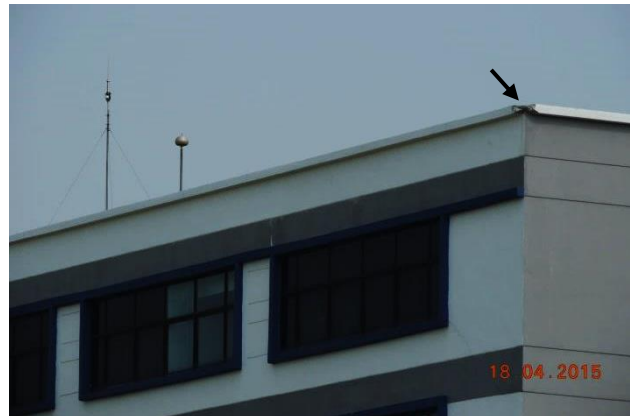
Fig. 4.8. The same building observed with a bypass (arrowed) in 2015.

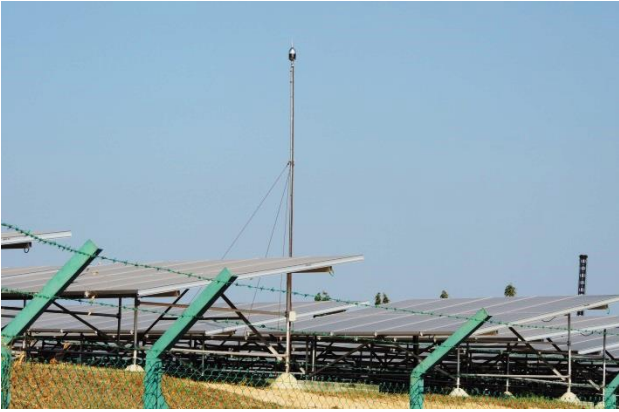
For example, in a reported lightning incident at a solar farm, several solar panels mounted about 1.5m above ground were struck by lightning although they were located within the claimed protection zone of one of several ESE air terminals that were installed throughout the farm.

Fig. 5.1. One of several mast-mounted ESE air terminals installed at a photo-voltaic farm where a bypass had occurred.

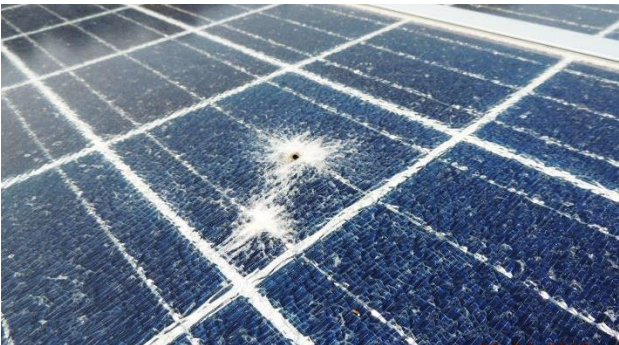
Fig. 5.2. Two of the bypasses on the center portion of a solar panel that was struck by lightning.

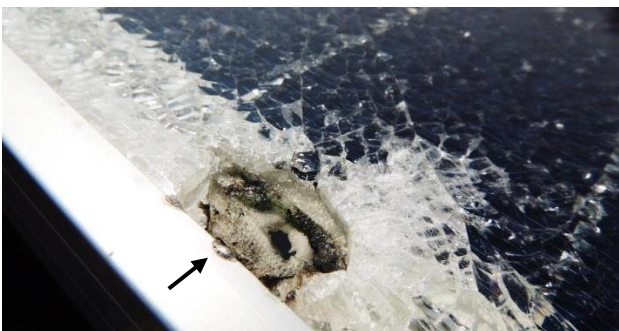
Fig. 5.3. One of the bypasses located at the edge of the solar panel. The blob of melted metal (arrowed) on the aluminum frame suggests that it was caused by a very high temperature event, such as a lightning stroke.

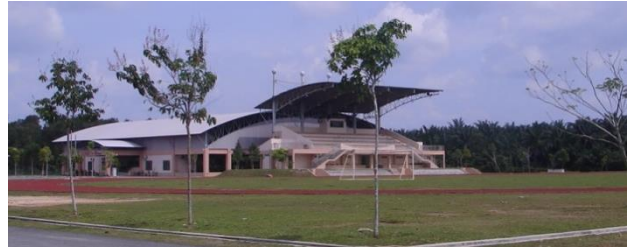
In 2012, a university student was struck and killed by lightning on a football field in front of a stadium grandstand. The metallic roof of the grandstand needed no protection against lightning but it had been installed with a pole-mounted ESE air terminal whose claimed protection zone covered the entire football field adjacent to the grandstand.

Fig. 5.4. The Malacca university stadium grandstand and field where the student was struck and killed by lightning.

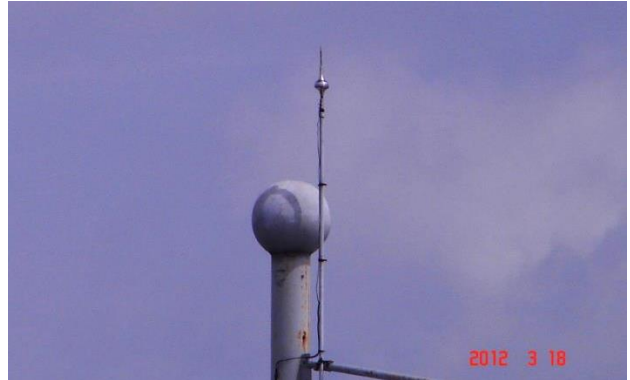
Fig. 5.5. The ESE air terminal mounted on one of the grandstand's metallic pillars.
