Conventional and Unconventional  
Lightning Air Terminals

# Conventional and Unconventional Lightning Air Terminals: An Update

HARTONO Zainal Abidin, BSc, MIEEE and ROBIAH Ibrahim, BSc, MIEEE

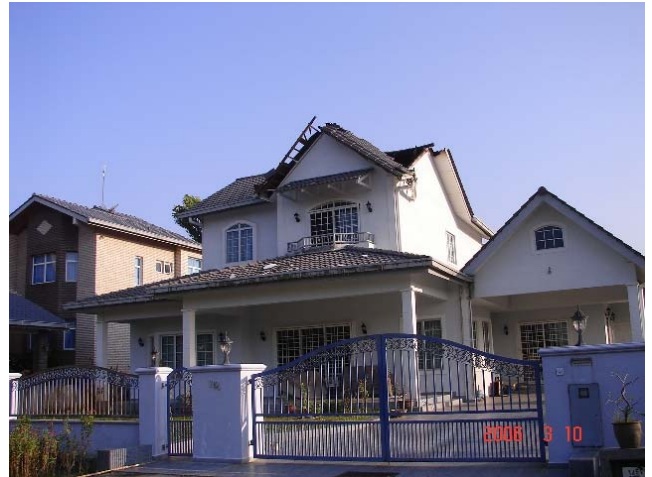
Fig. 1: The damaged roof of a house that was struck by lightning.

Lightning struck the roof of a house which is adjacent to another house that had been installed with an ESE air terminal. The roof was partially burnt as a result of the strike. This case shows that the ESE air terminal is not capable of protecting clustered small buildings.

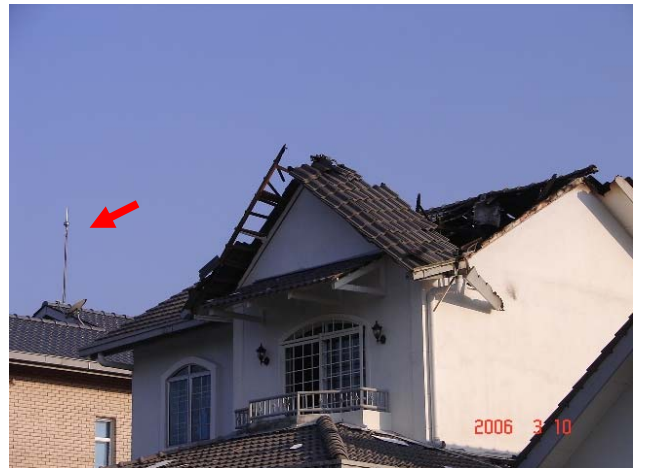
Fig. 2: Close-up view of the ESE air terminal (arrowed) on the adjacent house.

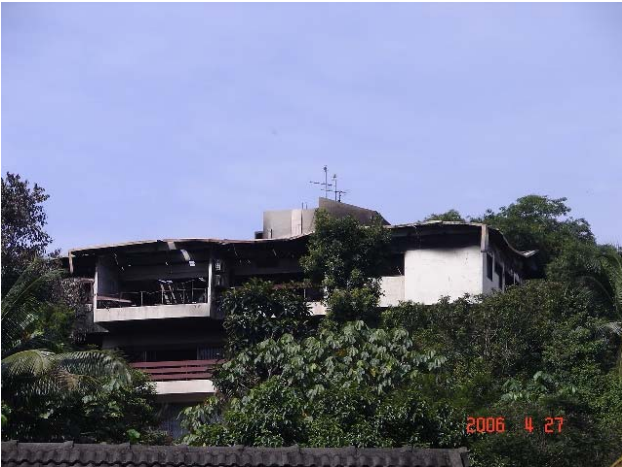
Fig. 3: The fire damaged top floor of a house that was struck by lightning.

Lightning struck the roof of a house which had been installed with an ESE air terminal. The roof and upper floor were badly burnt as a result of the lightning strike. This case shows that the ESE air terminal is not capable of protecting small buildings like a detached house.

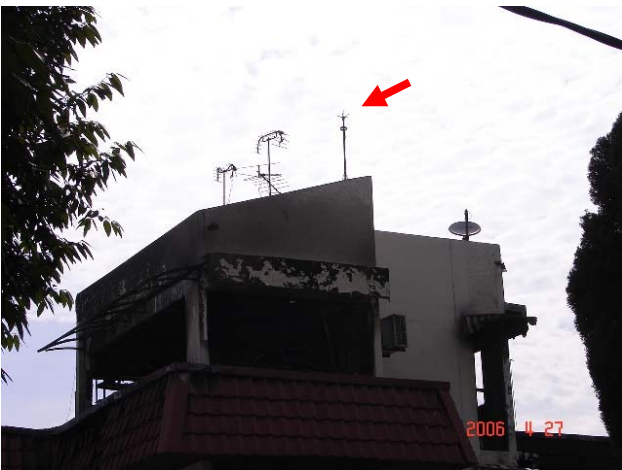
Fig. 4: Close-up view of the ESE air terminal on the roof (arrowed).

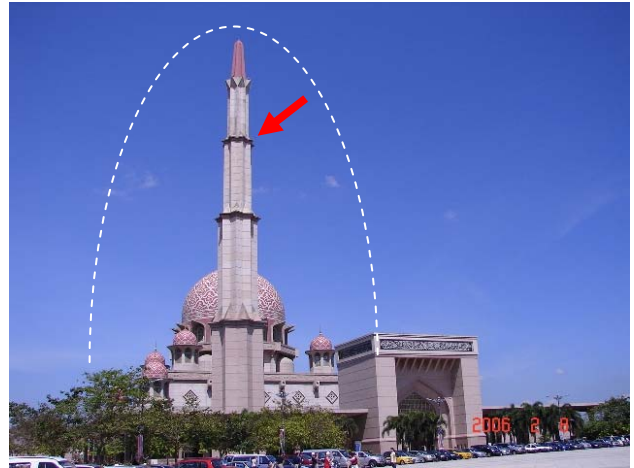
Fig. 5: Minaret of Putrajaya Mosque. The claimed protection zone is shown by the dotted line while the lightning strike location is shown by the arrow.

The minaret of the mosque, completed in 1998, is a slim 116 m high structure that was installed with a single ESE air terminal on the apex. According to the RSM, the sides of the minaret from about 50 m and above are exposed to lightning strikes and require protection.

The protection provided by the ESE air terminal, according to the NFC 17-102 "standard", should be at its best since the diameter of the minaret is less than 10 m. However, in 2005, lightning struck the side of the minaret about 30 m below the apex. This clearly shows that the claimed enhanced zone of protection for the ESE air terminal is non-existent.

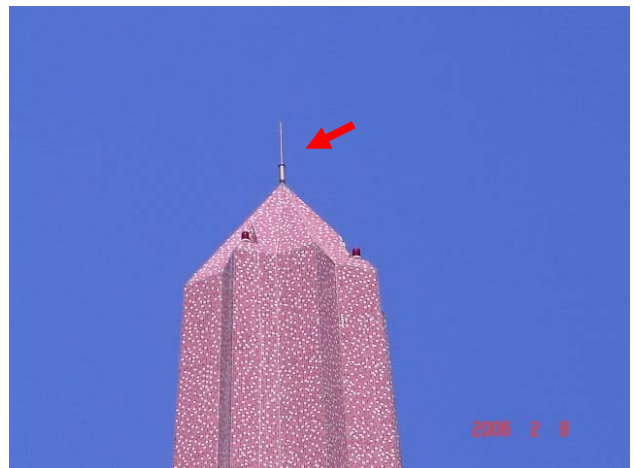
Fig. 6: An ESE air terminal on the apex of the minaret (arrowed).

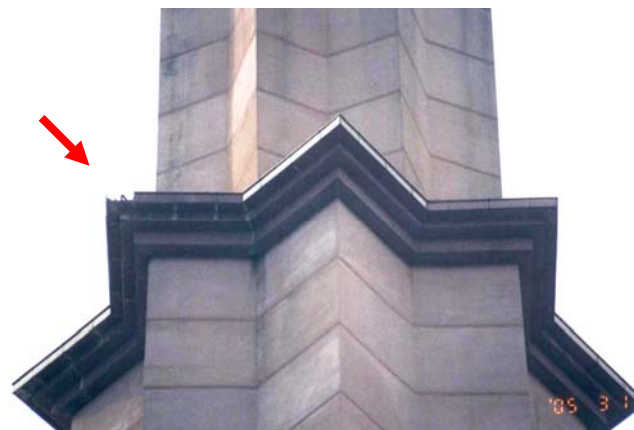
Fig. 7: Close-up view of the lightning damaged section of the minaret (arrowed).

The failure of the ESE air terminal to protect the minaret explains why normal buildings are always struck by lightning on the upper corners and edges. This is due to the fact that these locations fall outside the hypothetical ESE protection zone. Installing the ESE air terminals on tall poles also has no effect on enhancing the protection zone.

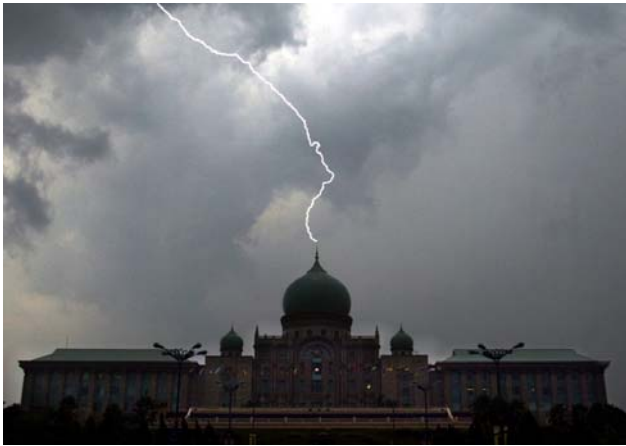
Fig. 8: A photograph of lightning striking the ESE air terminal on the Prime Minister Department building. (Photo credit: The Star Publications plc)

This large building has been installed with at least five ESE air terminals, one on the apex of the dome and four on ridge ends of the metal roofs below the dome. A photograph of a lightning strike to the dome air terminal was recently captured by a news photographer.

An analysis of the lightning path that terminated on the air terminal shows that the ESE principle is incorrect. If it was correct, then the lightning path would be approximately straight for several tens of meters above air terminal since the streamer would be moving towards the down leader.

The curved path of the lightning stroke just above the air terminal indicates that no streamer was emitted. In addition, no visible streamers were observed from the nearby ESE air terminals on the metal roofs. As already shown in the previous report, a corner of the building next to one of the lower ESE air terminals had been struck by lightning.

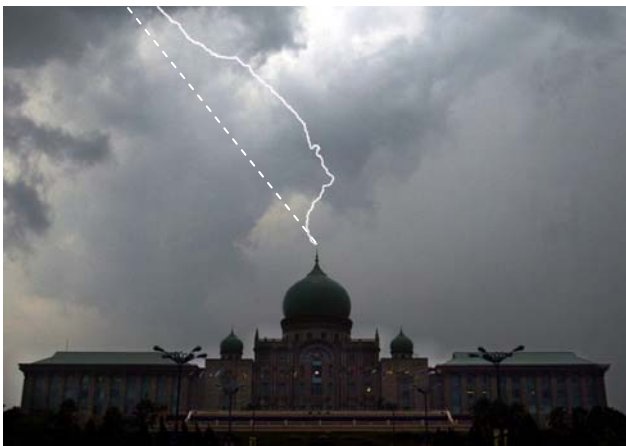
Fig. 9: The dotted line represents the hypothetical path of the early streamer according to the ESE hypothesis. (Photo credit: The Star Publications plc)

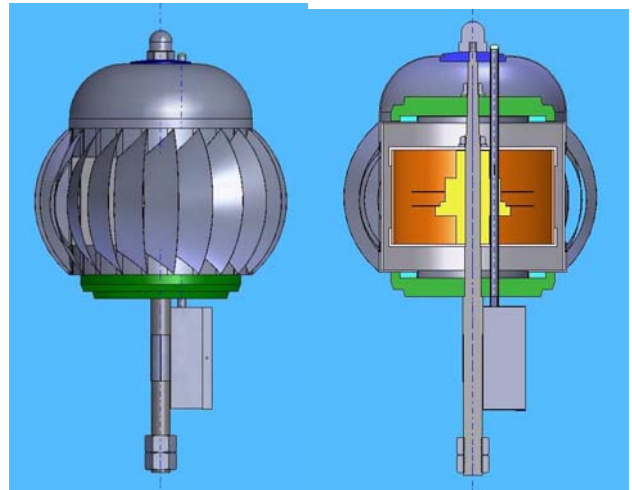
Fig. 10: Side (left) and cross-section (right) views of the UTM invented ESE air terminal. The box-shaped laser device is located below the wind-operated static generator. (Photo credit: UTM)

In a study by Sidik and Ahmad [10], a new ESE air terminal equipped with a wind-driven electrostatic generator and a palm-sized laser device was invented. They claimed [11] that the laser device is capable of attracting lightning strikes and that the air terminal operates on the CVM principle. They also claimed [12] that their invention need not be installed on the building for protection against direct lightning strikes.

Several western studies have shown that the laser devices required to ionize very long air paths to create conducting channels for lightning are large and powerful; hence the claim that the palm-sized laser device can produce the same results in the field is doubtful.

The use of a wind-driven static generator means that the streamer generation is only practical on windy days. The CVM claim is unproven since the method had already been discredited and rejected by Standards Australia and the NFPA.
