# Clear Evidence of Lightning Strikes to a Building Installed with Multiple ESE Air Terminals

HARTONO Zainal Abidin

*Lightning Research Pte. Ltd.*

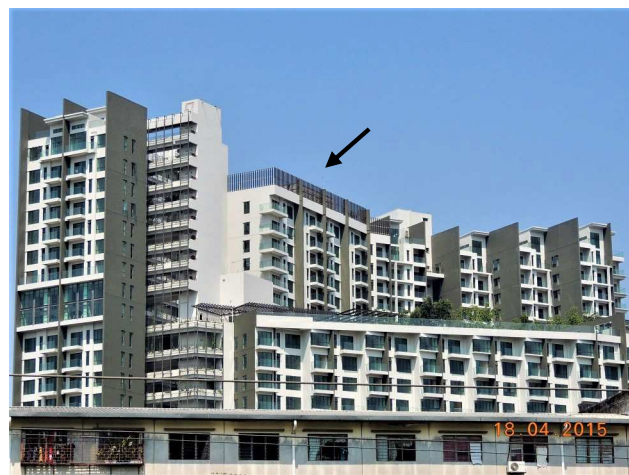
The UNIV360 Place condominium was completed in early 2015 and is located next to a major highway; hence it is possible to monitor the building on a regular basis and photograph the appearances of new bypasses (Fig. 1 and 3).

Figure 1 View of UNIV360 Place from the East (highway) showing the location of ESE#1 (<https://goo.gl/maps/HwJsuMdbxJYewCb2A>)

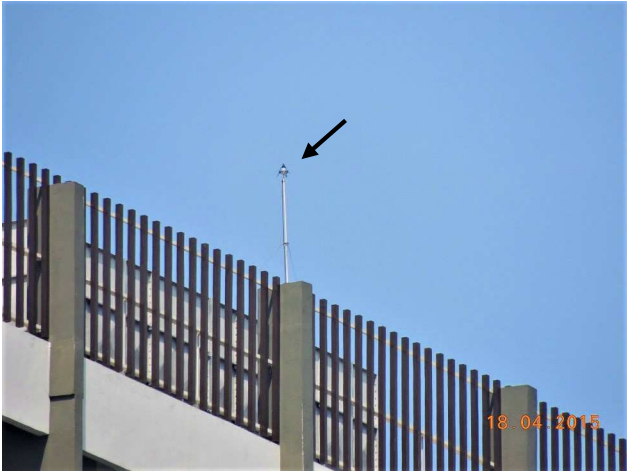
The building was initially photographed with ESE#1 (Fig. 2) installed in April 2015. In the 8-month period from October 2015, a total of five bypasses were photographed.

Figure 2 Close-up view of ESE#1 (Type: PREVECTRON ESE-AT)

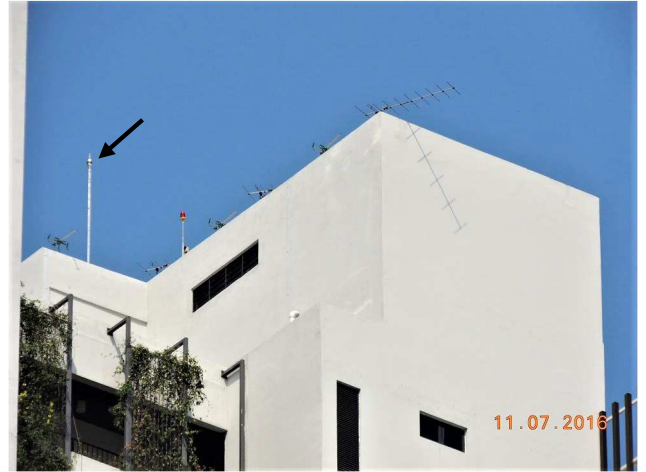
The above two AT were installed in response to the failure of ESE#1 to protect the building from being struck by lightning repeatedly. Since they were installed at approximately midway between ESE#1 and the far ends of the building, the horizontal distance between them and the far ends of the building is approximately 40 m.

Figure 11 ESE#2 (Type: SCHIRTEC ESE-AT)

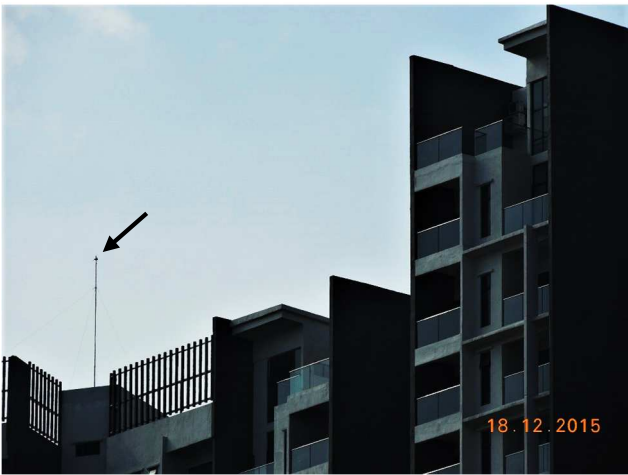
Figure 9 ESE#1 before it was remounted on a taller pole

| Photograph date | Item photographed |
|---|---|
| July 2016 | ESE#1 remounted on a taller pole (Fig. 9 and 10); ESE#2 (Fig. 11) and ESE#3 installed |
